NASA/TM-2004-213231/Version 0.01
NESC-RP-04-01/03-001-E

Cloud-Aerosol LIDAR and Infrared Pathfinder Satellite Observation (CALIPSO) Spacecraft

Independent Technical Assessment

ITA #: NESC-RP-001	
Requestor Name: William F. Townsend NASA Goddard Space Flight Center (GSFC) Deputy Director	Requestor Contact Info: (301)-286-5066 william.f.townsend@nasa.gov Code 100
Short Title: CALIPSO Spacecraft Proteus Propulsion System Assessment	
Description: Personnel hazards associated with Proteus Hydrazine propulsion bus once loaded (launch-36 days)	
Date Received: 10-22-03	Date ITA/I Initiated: 11-06-03
NESC Chief Engineer (NCE) Assigned: Michael Hagopian	NCE Contact Info: 301-286-6732
Lead Assigned: Dr. Richard J. Gilbrech	Lead Contact Info: 757-864-3303
Date ITA/I Concluded: 1-27-04

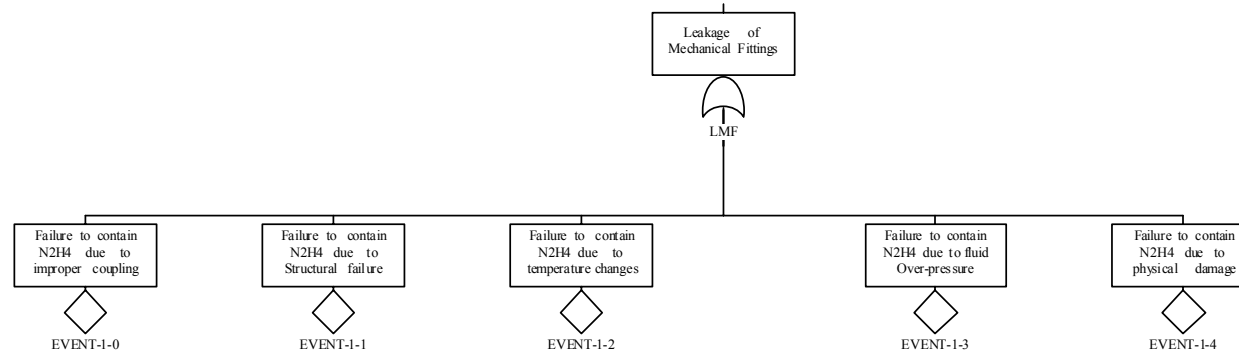
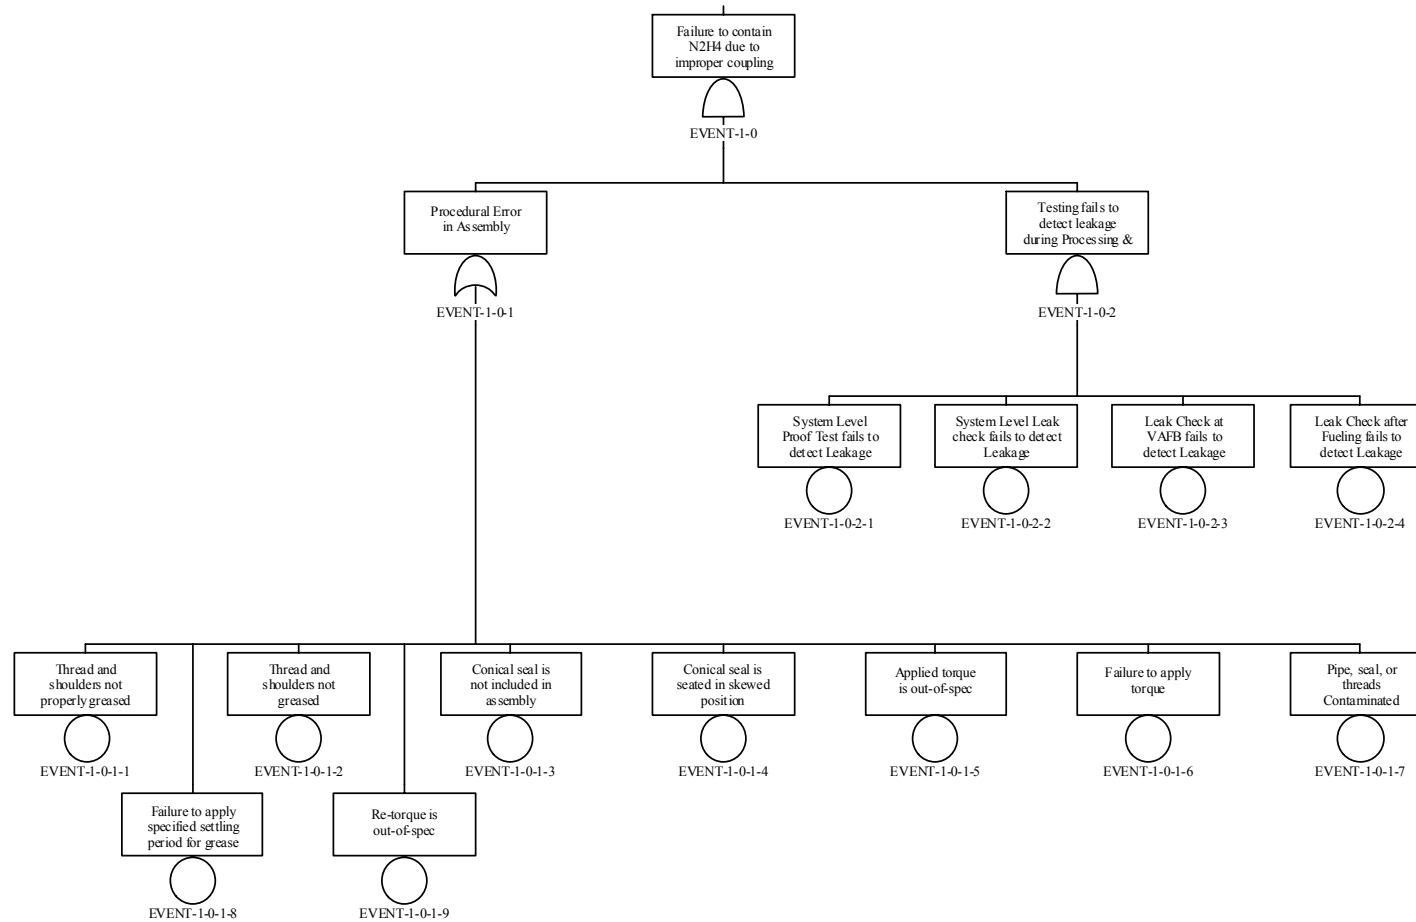
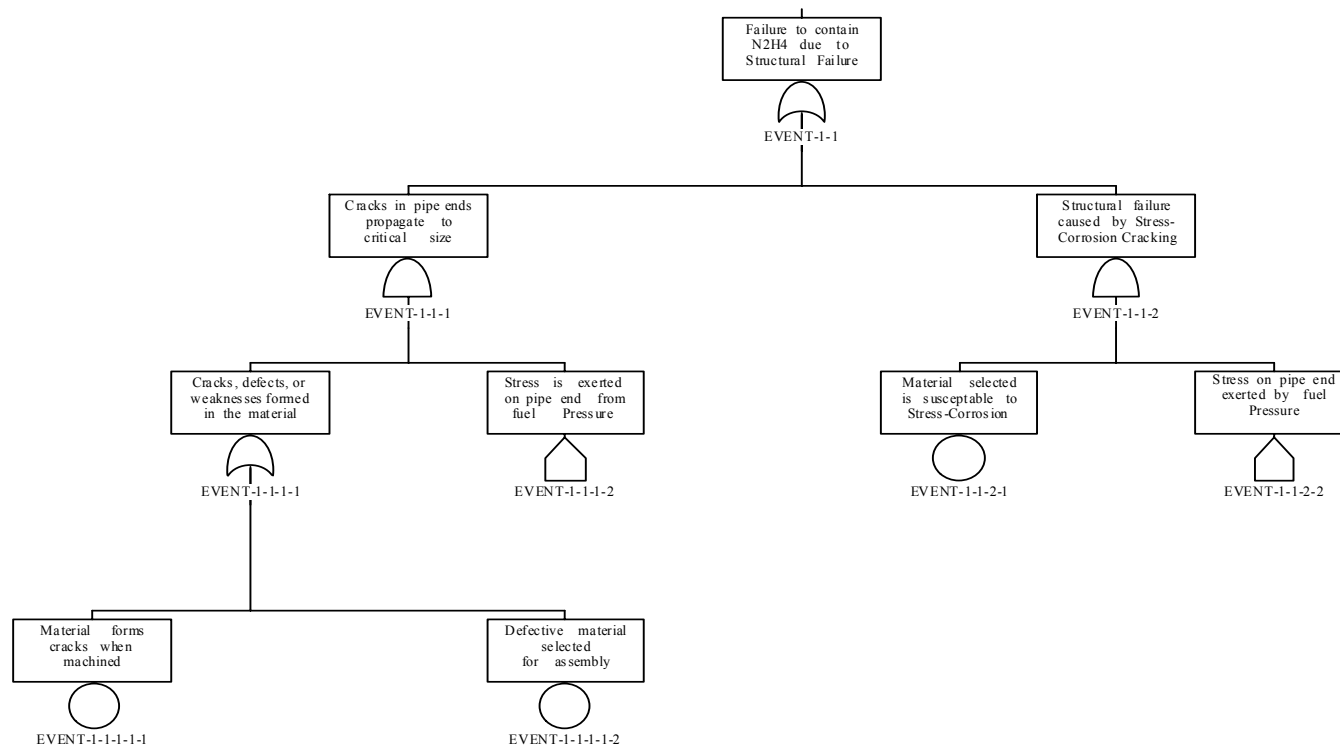
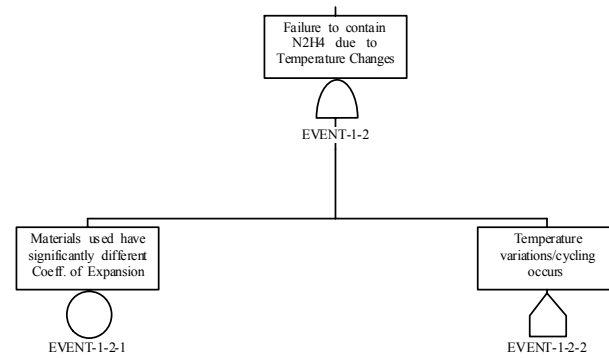
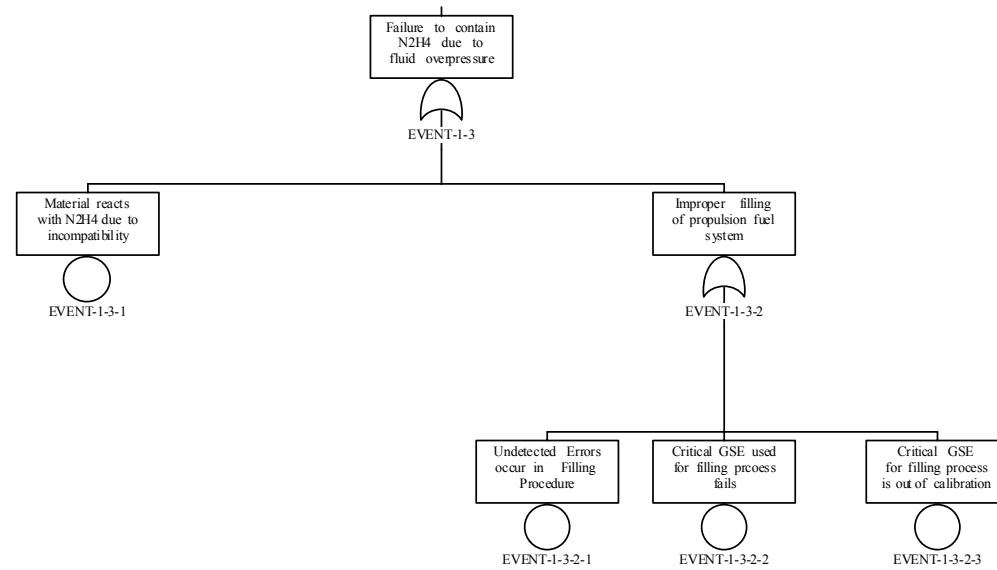
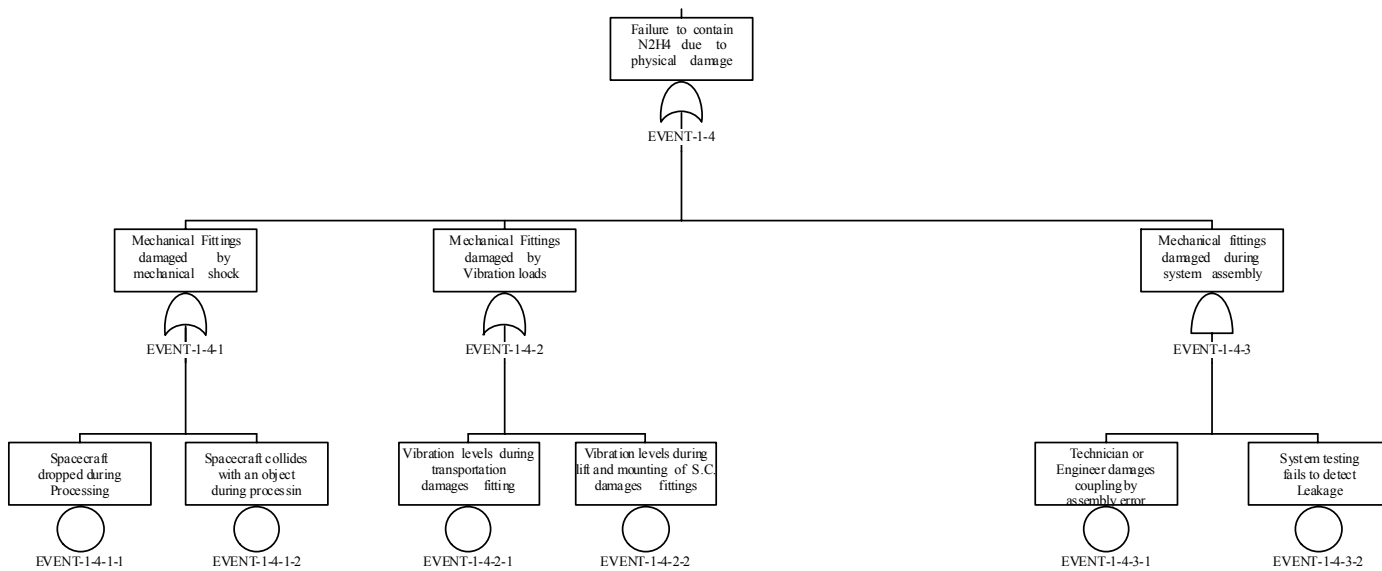
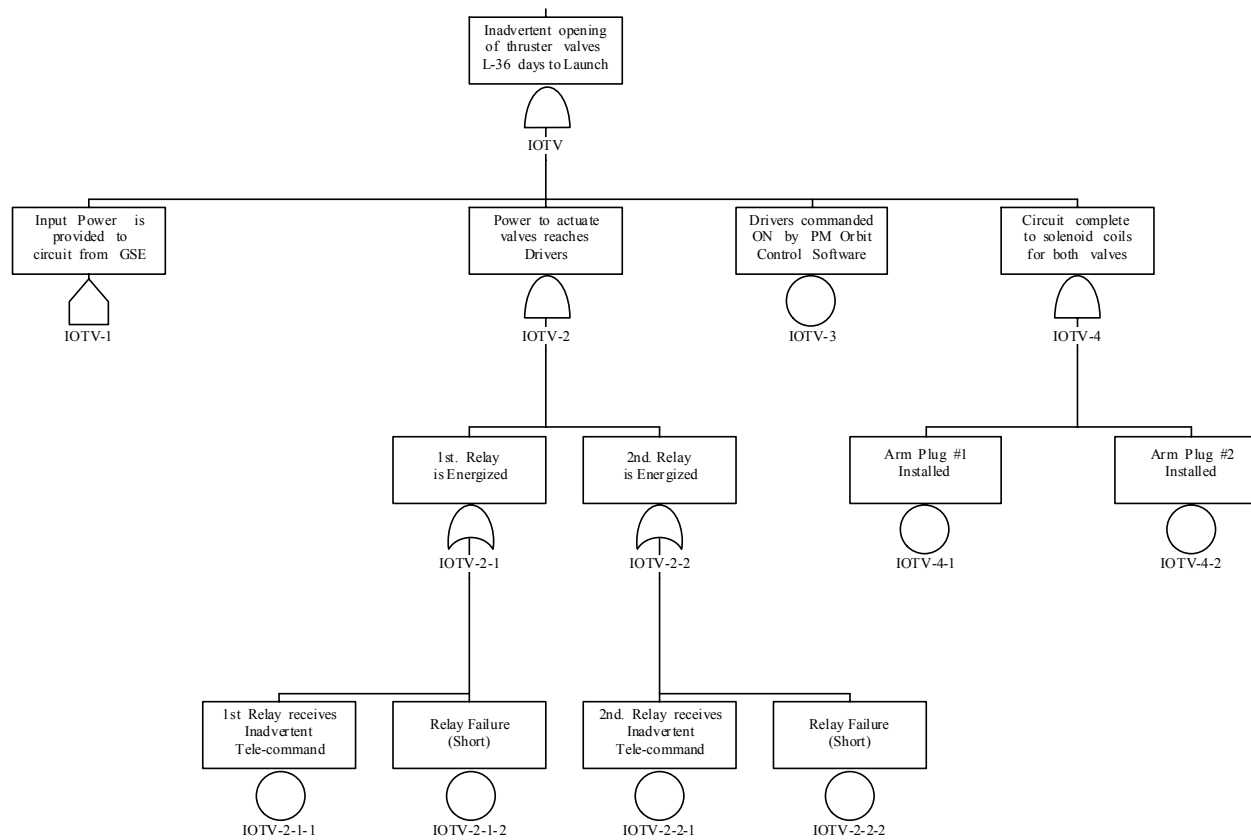
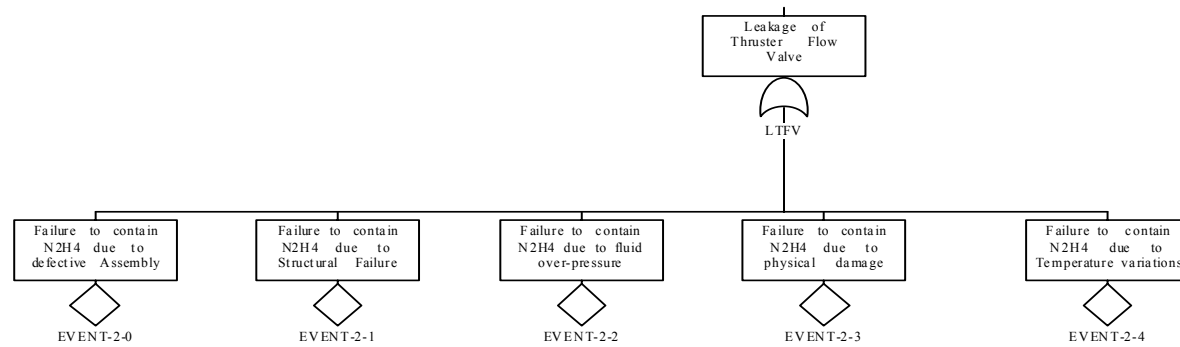
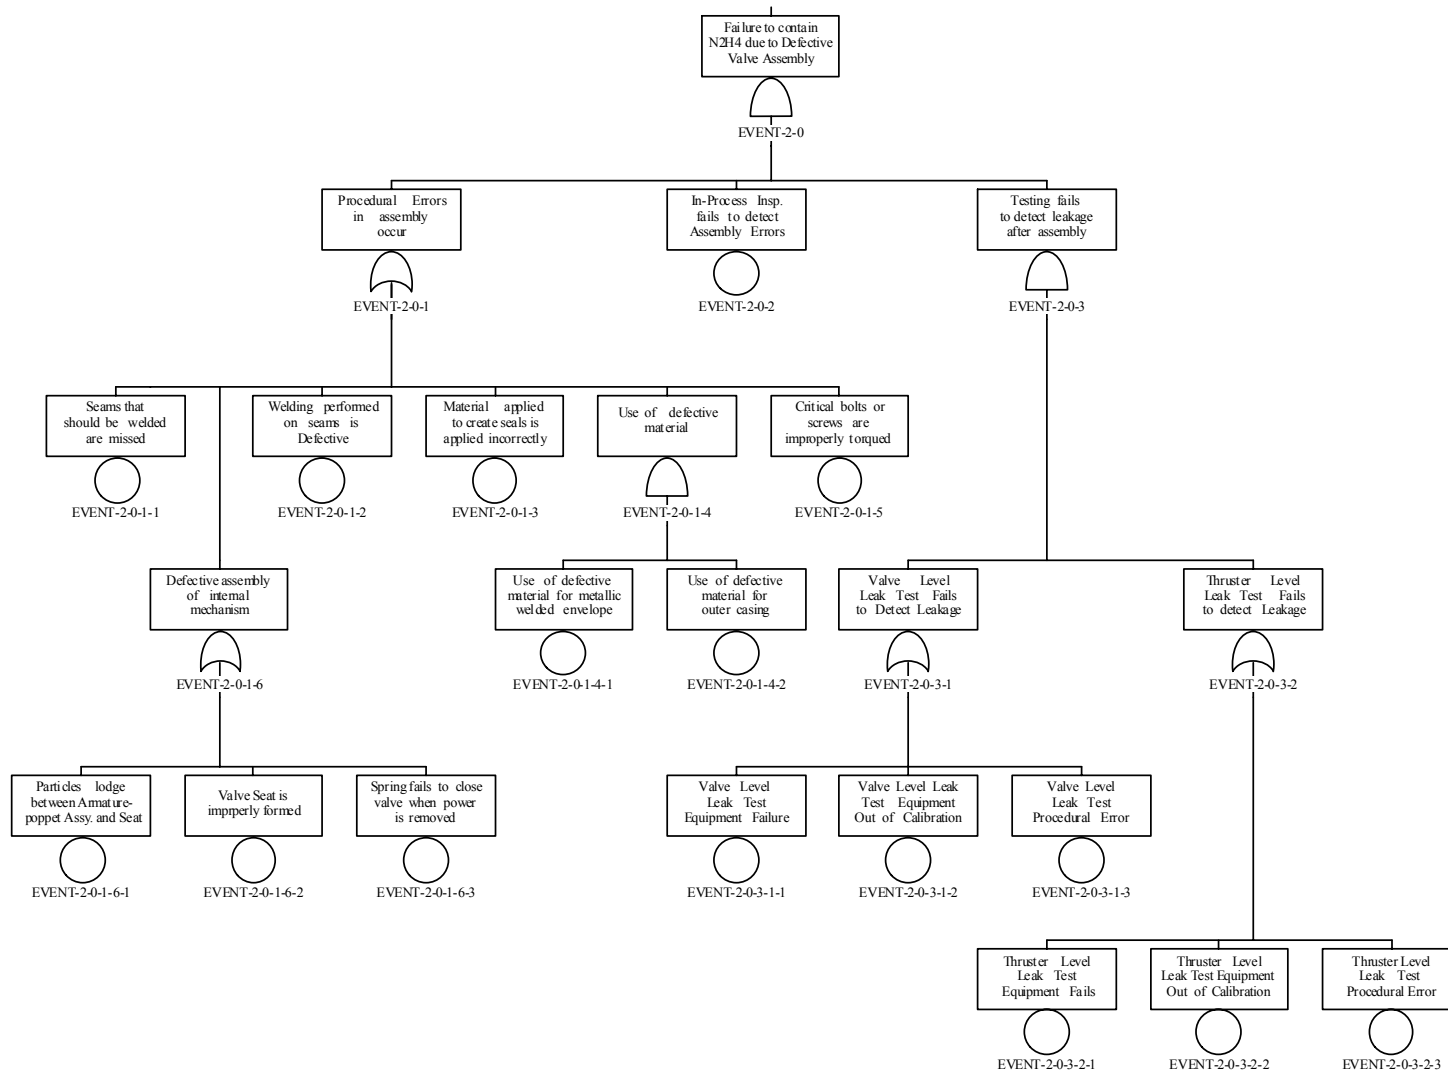
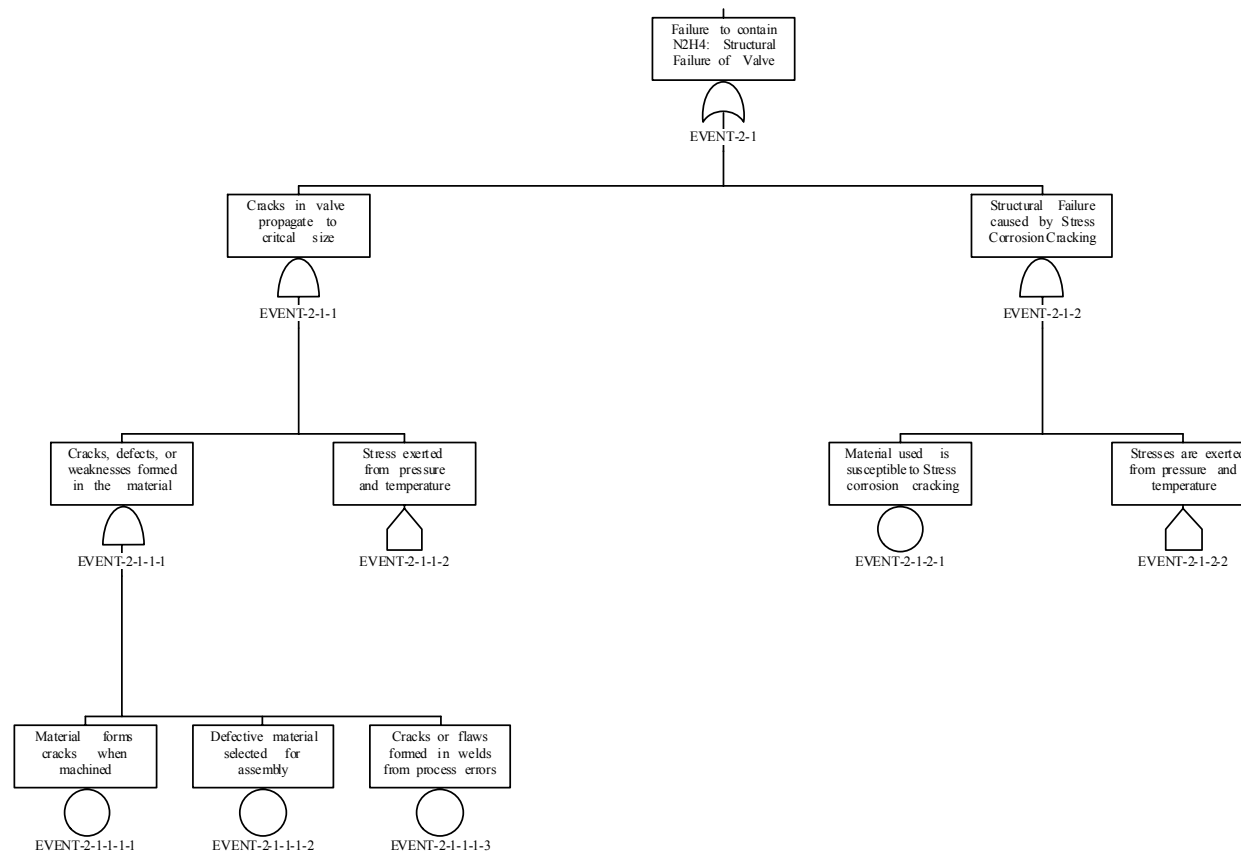
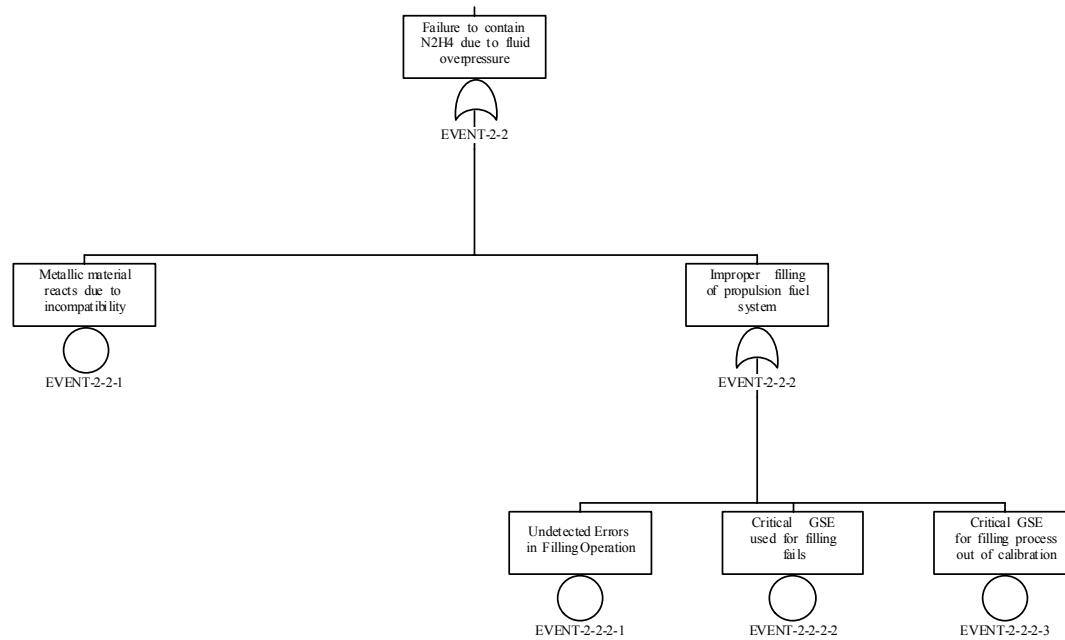
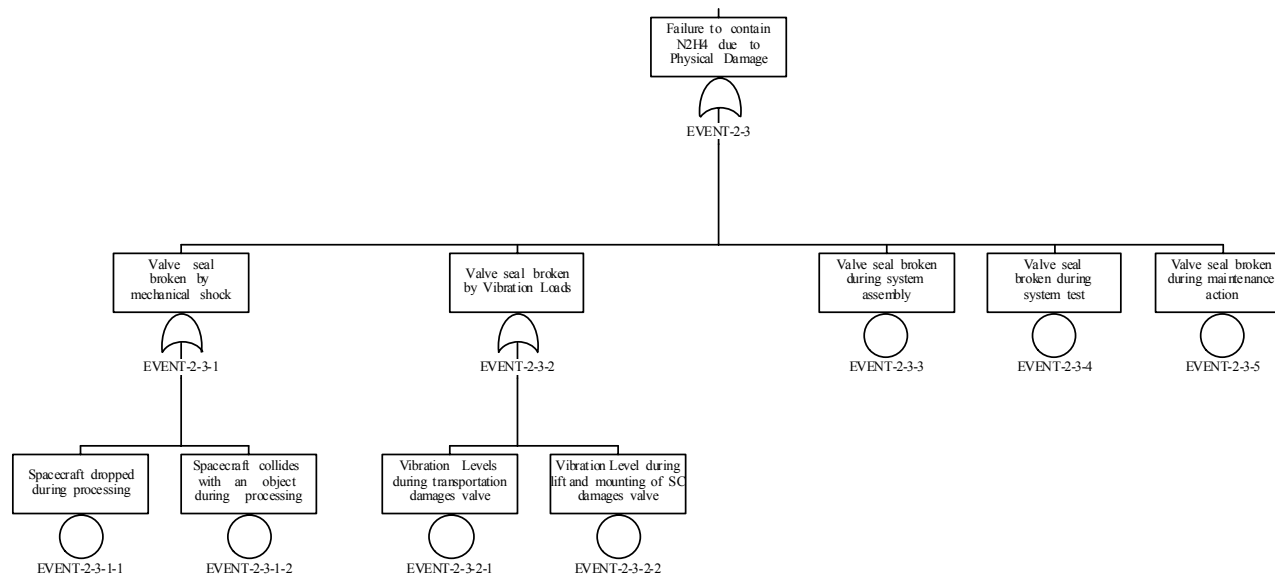
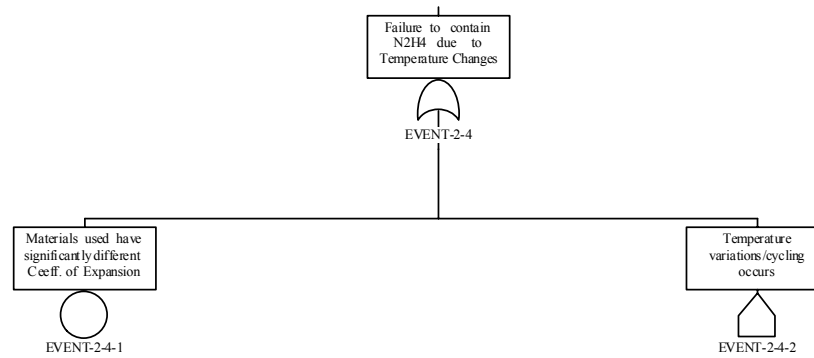
Appendix B. CALIPSO Fault Tree Analysis

NESC focused on the three key issues as stated above. A detailed assessment of the causal factors that could potentially lead to a catastrophic event can be found in the NESC-developed fault tree (ref. Appendix B). A more general discussion follows.

The fact a hazardous event is unlikely to occur does not mean it *cannot* occur. For the three fault tree events considered in Appendix B (leakage of the mechanical fittings, leakage through the thruster valves and inadvertent firing of the thruster) a wide range of probabilities were derived by the GSFC and LaRC safety offices along with differing opinions on severity. There is subjectivity in determining an event probability as evidenced by the wide spread between the two safety offices. It was not feasible for the NESC to better quantify the probabilities through specific testing or analysis in the timeframe given. Hydrazine is a hazardous commodity and in the NESC assessment team's judgment, the possibility of leakage does exist and the event severity is catastrophic to personnel. Given this premise, the focus of this assessment was to minimize the probability that the current design could initiate these undesired events and ensure operational controls are in place to maximize personnel safety.

Fault trees for each of the potential failures under assessment were developed as presented in Appendix B. Credible failure modes were identified and the controls the CALIPSO program has placed on those failures assessed. For failures the program has not already assessed or for which controls were deemed inadequate, independent testing was conducted to validate the program's approach or additional controls were recommended.

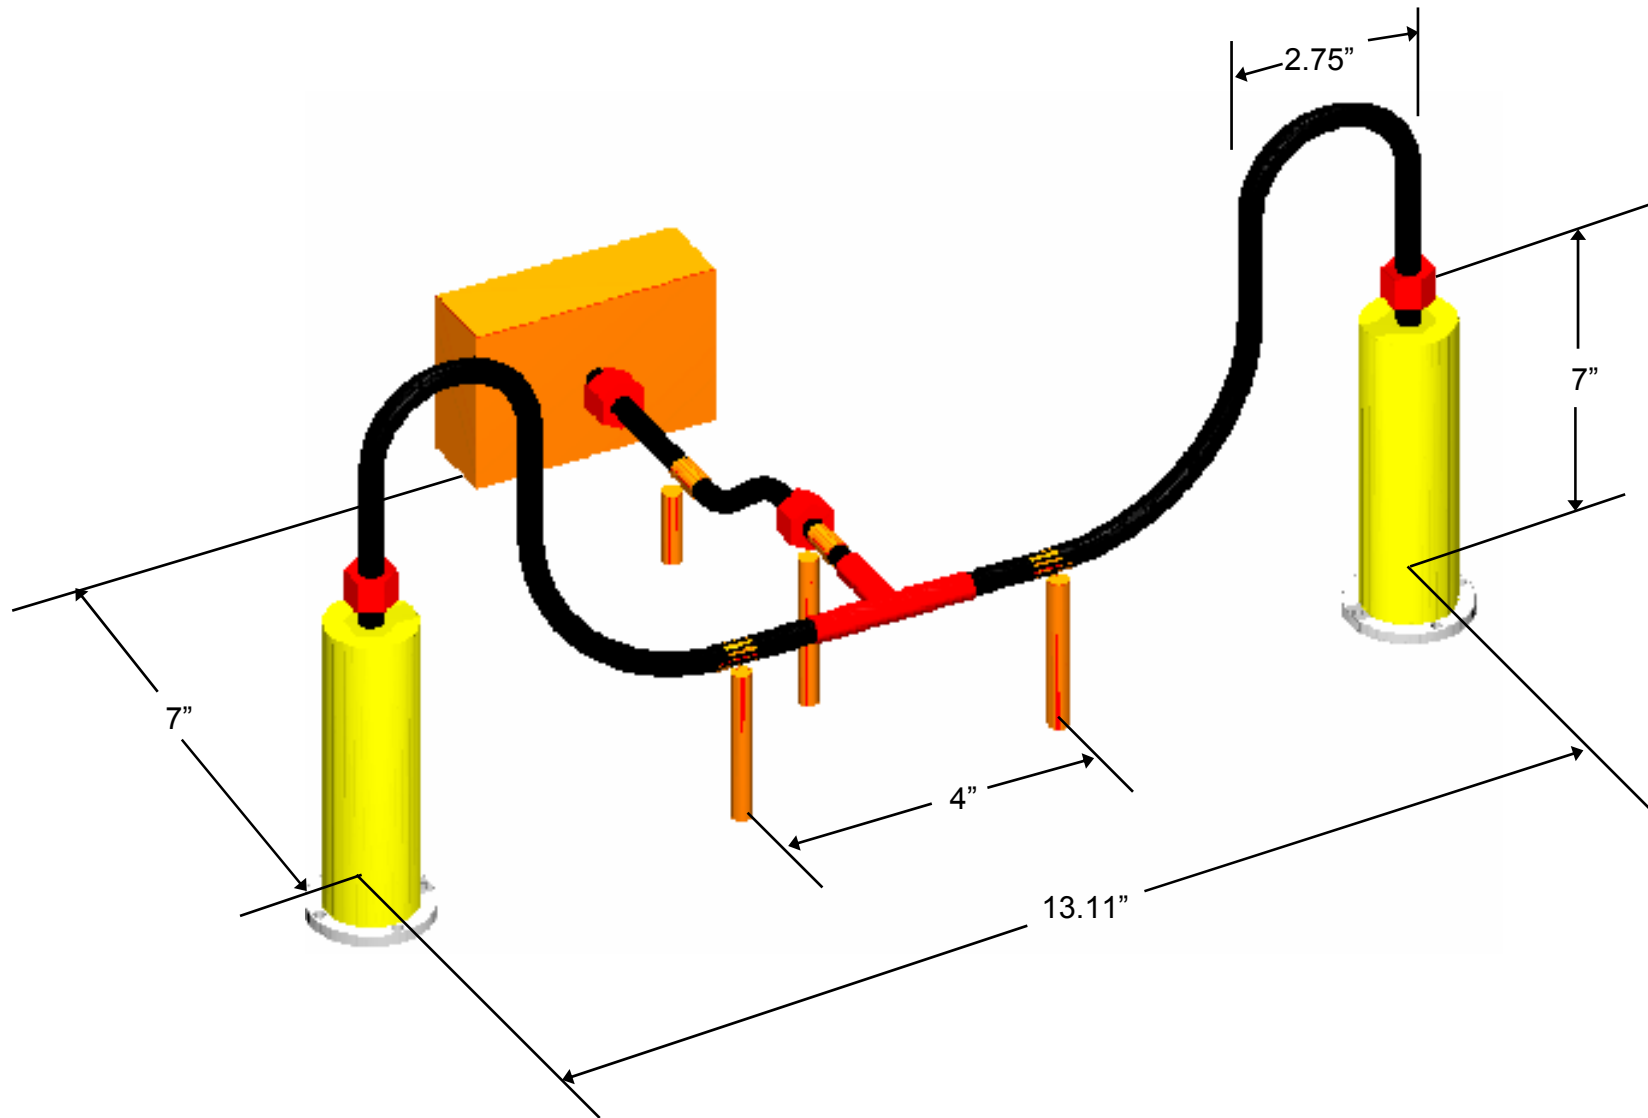
Hot Soak Test Setup

- **Four fittings to be tested: Two in titanium line, and two CRES at thruster location**
 - Thruster fittings simulated for hot soak test due to the uncertainty of the valves acquired. Valves need to function properly when exposed to hydrazine for decontamination purposes.
- **Lines filled with hydrazine and stored in oven**
 - Temp at 225°F; Line pressure at 320 psig; Duration of 3.5 days
